# **Teardown Evaluation of Areas of Interest From the T-34A N141SW Aircraft Wreckage**

March 2006

DOT/FAA/AR-TN05/57

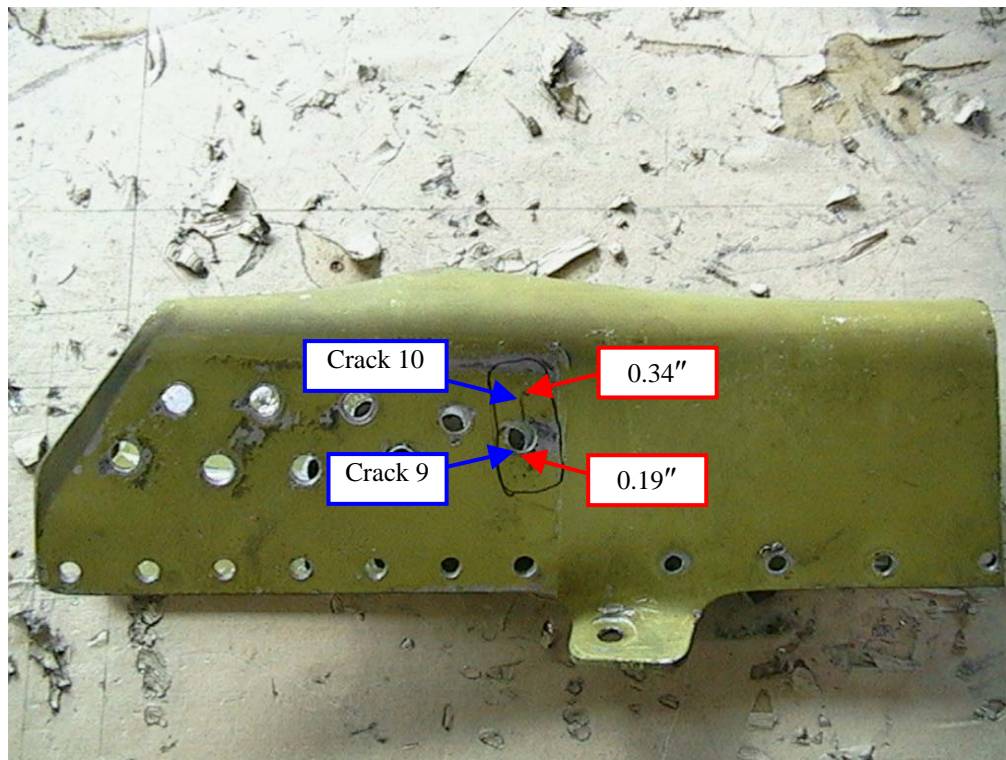
The right wing front carry-through was partially disassembled, and a surface scan eddy-current inspection was performed around nine attachment boltholes on both the forward and aft sides of the structure. This scan indicated a crack on the aft side of the right wing front carry-through outer (-33) channel, shown in figure 3. Other cracks on this same detail were not detected using surface scan eddy current due to excessive crushing of the structure during impact, which limited inspection access.

FIGURE 3. AFT SIDE OF THE RIGHT WING FRONT CARRY-THROUGH OUTER (-33) CHANNEL, CRACKS 9 AND 10

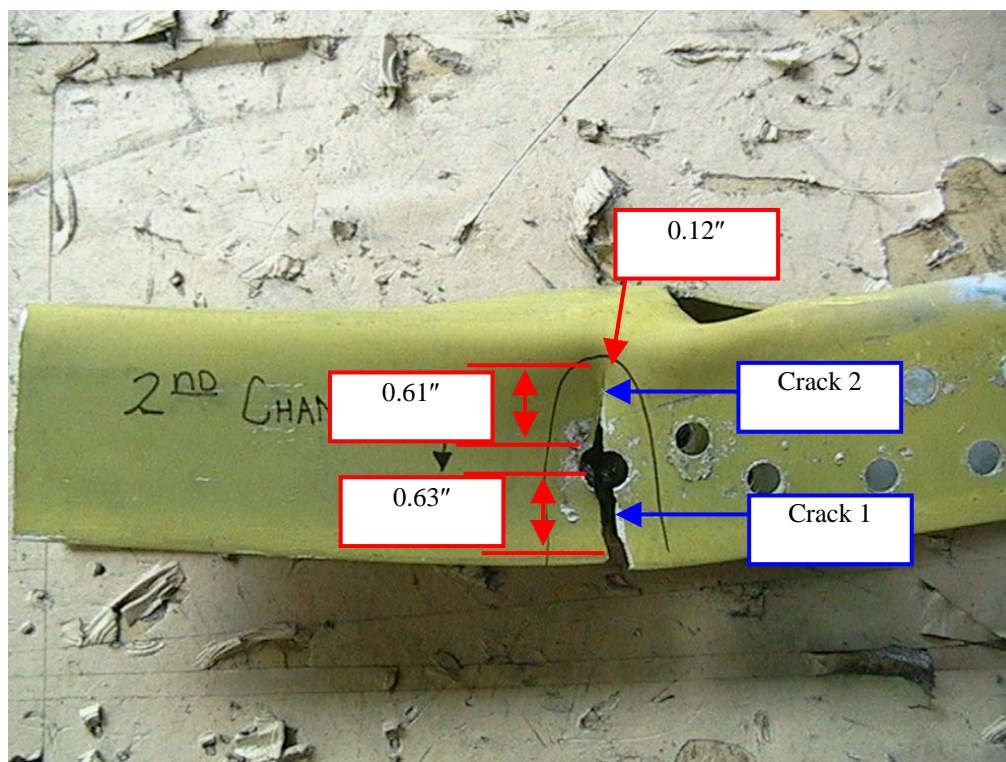
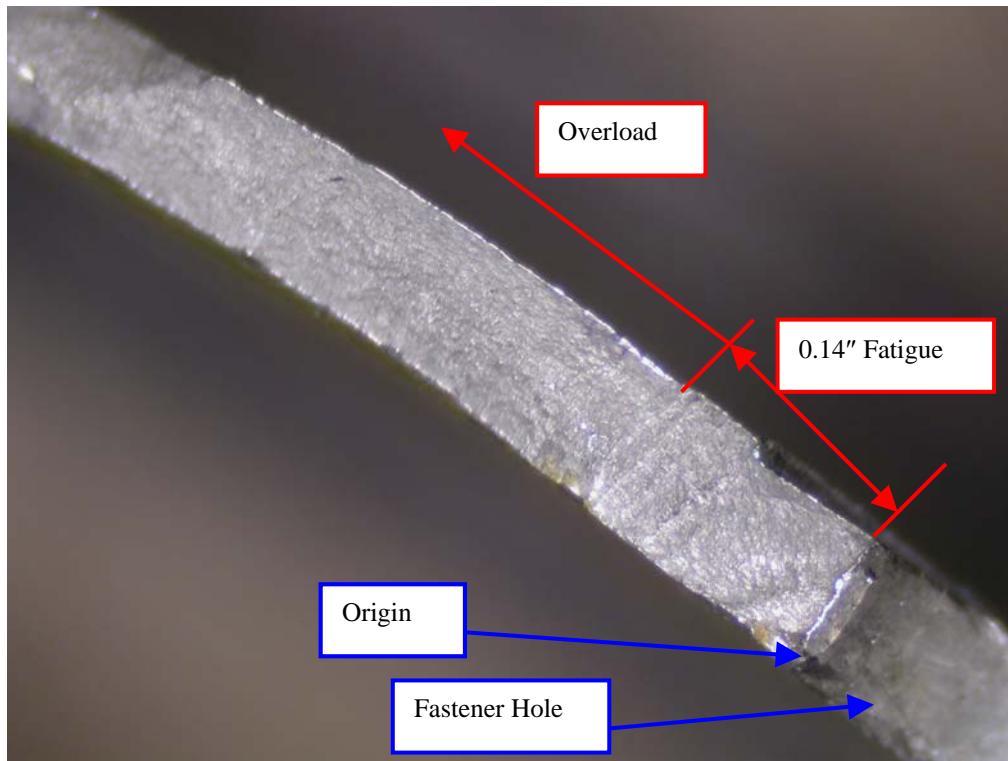
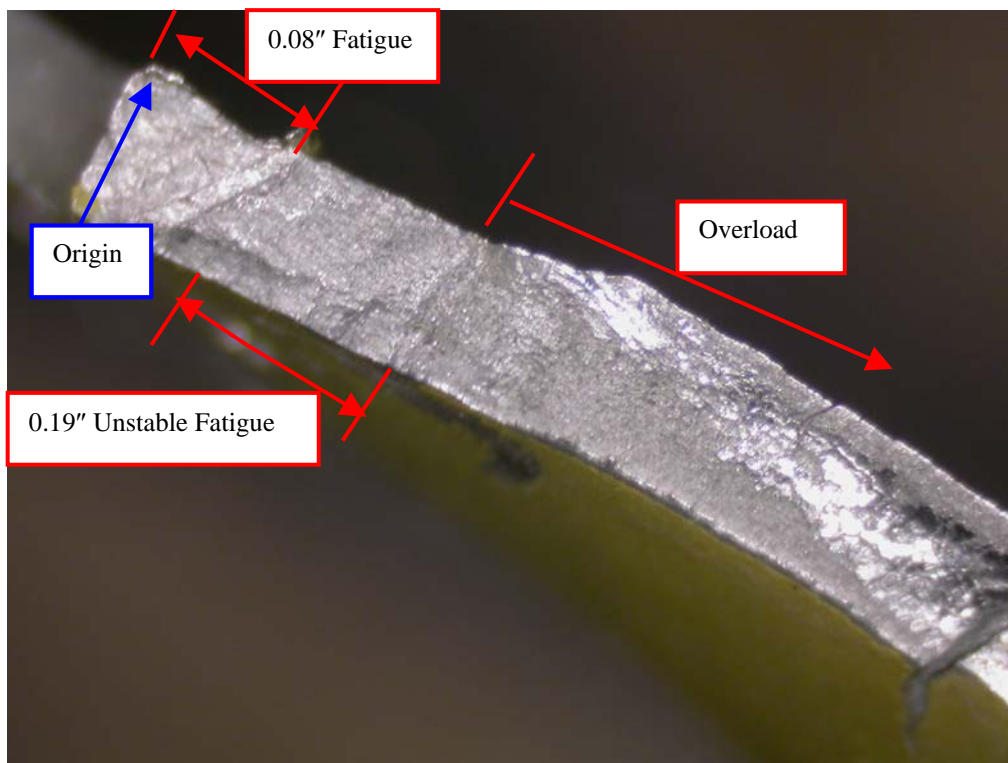
The right wing front carry-through was examined microscopically for cracks and corrosion. Figure 9 shows the locations of two cracks, cracks 1 and 2, on the right wing front carry-through middle channel forward side, part number 45-410215-31. Most cracks found on the right wing front carry-through began as fatigue cracks, but were lengthened due to overload. Crack 1 had a total length of 0.63 inch. The initial 0.14 inch of this crack failed due to fatigue, with the remaining growth due to overload. The crack face, shown in figure 10, shows that the origin of the crack was located near the edge of a fastener hole. Crack 2 was 0.73 inch long, and its fracture face is shown in figure 11. As shown in this figure, the initial 0.08 inch of growth was due to fatigue, with the next 0.19 inch of growth due to unstable fatigue. All subsequent growth occurred due to overload.

FIGURE 9. LOCATIONS OF CRACKS 1 AND 2 ON THE RIGHT WING FRONT CARRY-THROUGH MIDDLE (-31) CHANNEL FORWARD SIDE

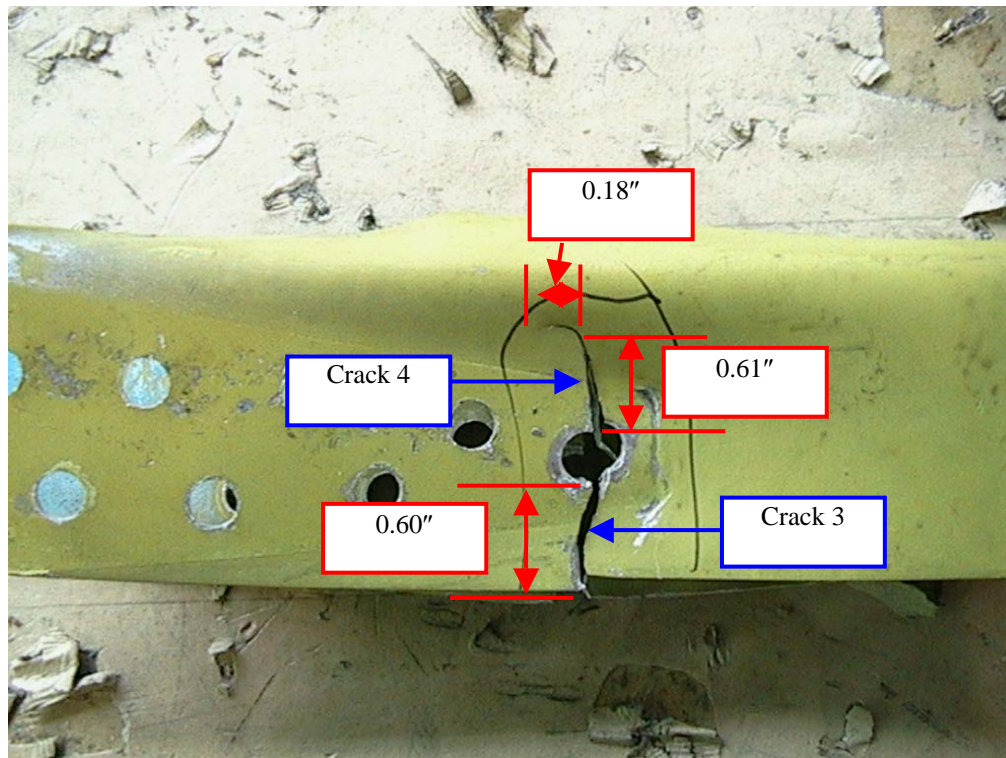
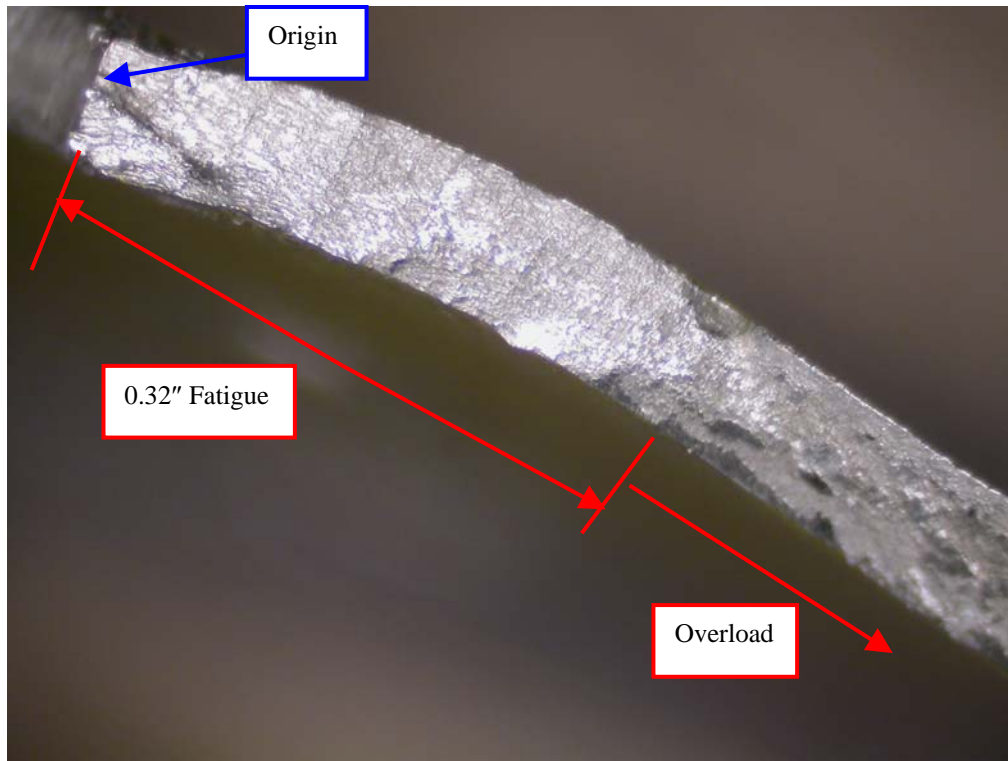
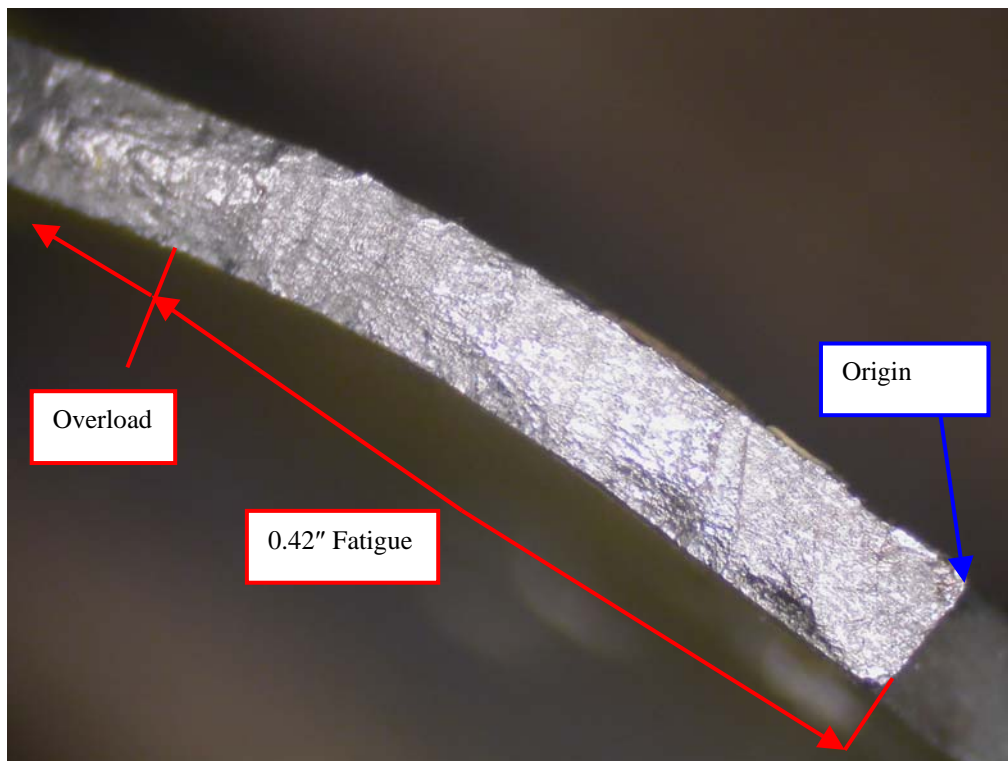
Figure 12 shows the locations of cracks 3 and 4 on the right wing front carry-through middle channel aft side, part number 45-410215-31. The fracture face for crack 3 is shown in figure 13, showing the location of the origin. The initial 0.32 inch of crack growth was caused by fatigue with the remaining 0.28 inch caused by overload. The fracture face of crack 4, shown in figure 14, provides the location of the origin for this 0.79-inch crack. It also shows the fatigue region of growth, which measures 0.42 inch, with the remaining growth of the crack due to overload.

FIGURE 12. LOCATIONS OF CRACKS 3 AND 4 ON THE RIGHT WING FRONT CARRY-THROUGH MIDDLE (-31) CHANNEL AFT SIDE

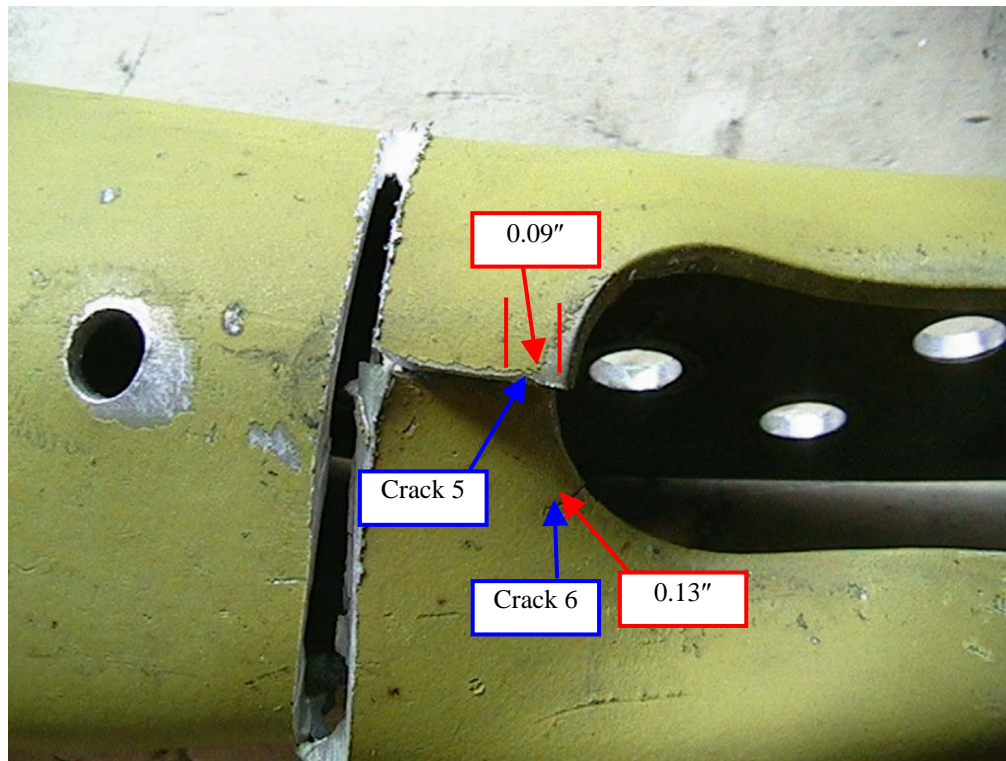
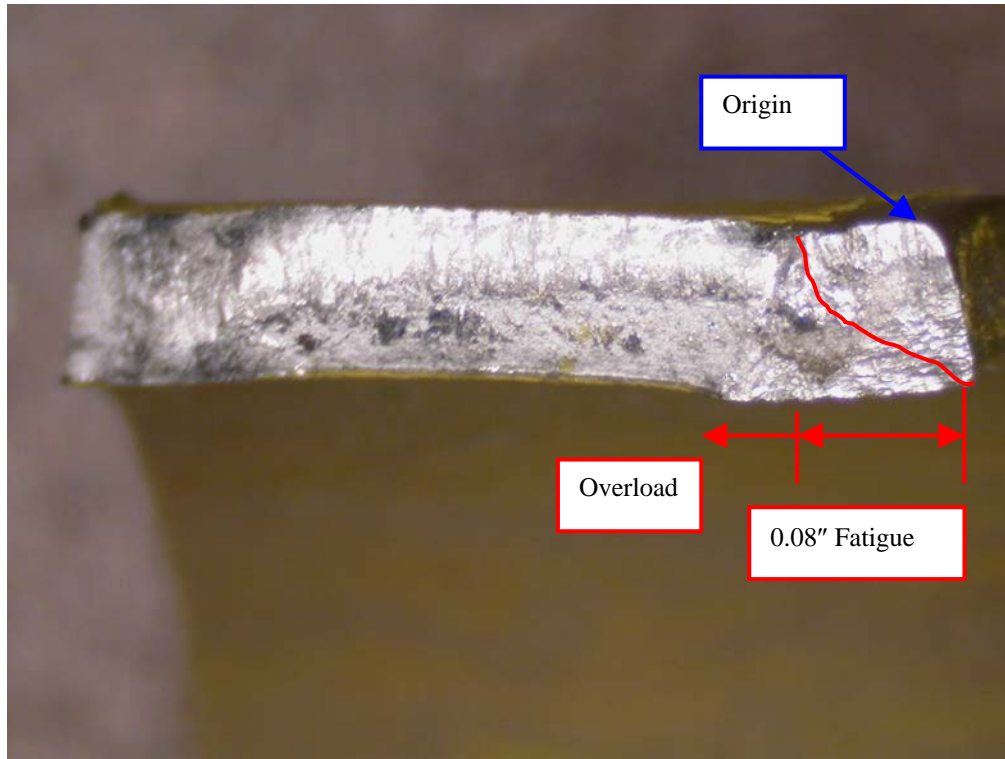
The locations of two cracks, identified as cracks 5 and 6, on the right wing front carry-through middle channel lower surface, part number 45-410215-31, are shown in figure 15. A picture of the crack 5 fracture face is provided in figure 16. This figure shows the location of the origin of this 0.09-inch-long crack. The shape of the 0.08-inch-long fatigue region is also shown in figure 16, illustrating that crack 5 had not grown completely through the thickness of the channel. Crack 6, which had a total length of 0.13 inch, was not opened for examination.

FIGURE 15. LOCATIONS OF CRACKS 5 AND 6 ON THE RIGHT WING FRONT CARRY-THROUGH MIDDLE (-31) CHANNEL LOWER SURFACE

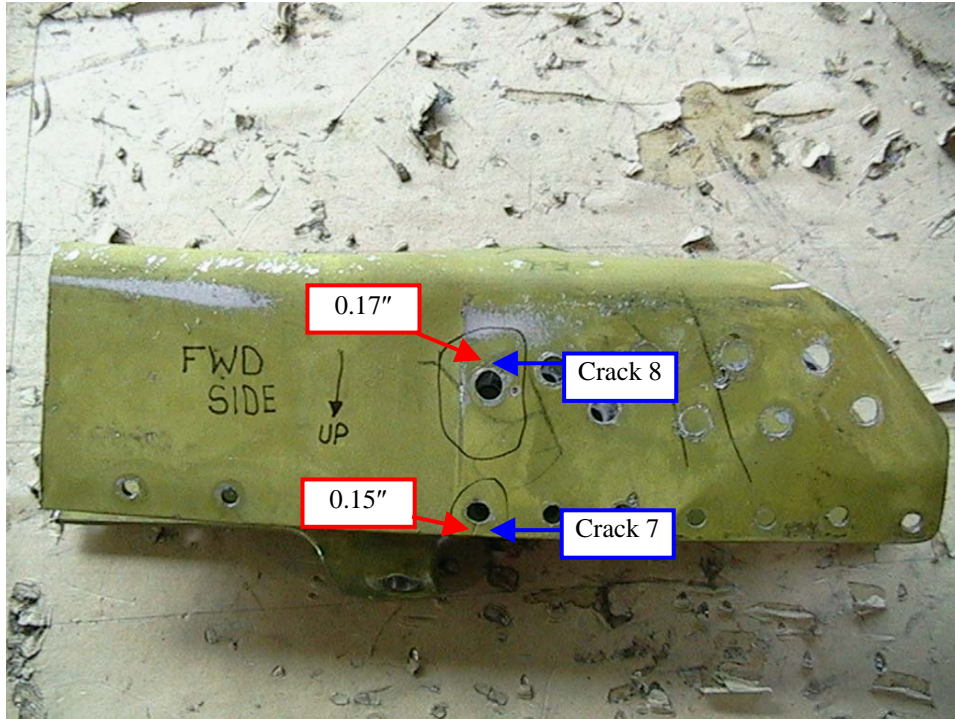
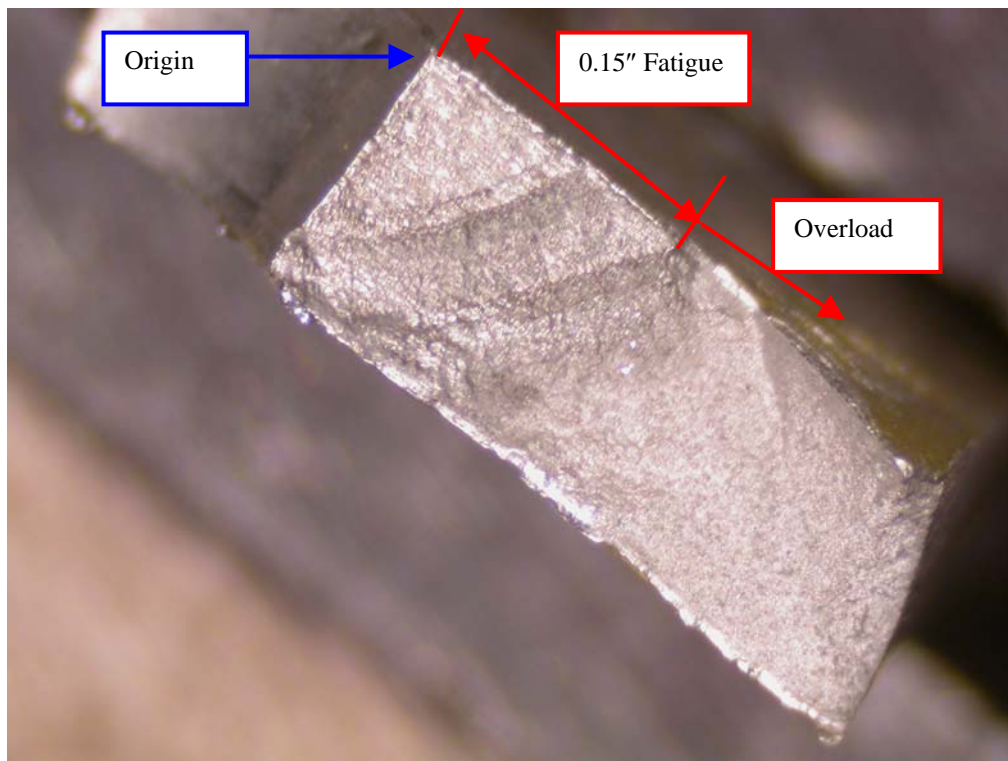
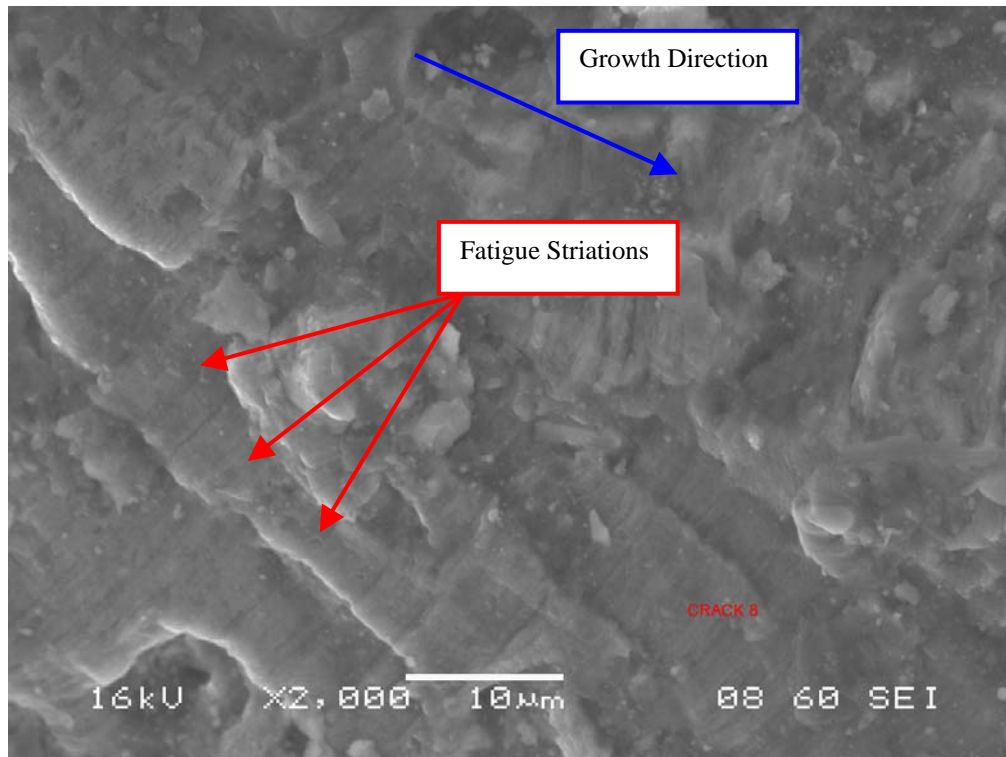
Figure 17 shows the locations of cracks 7 and 8 on the right wing front carry-through outer channel forward side, part number 45-410215-33. Crack 7 measured 0.15 inch in length and was caused solely by overload. The fracture face of crack 8, which measured 0.17 inch in length, is shown in figure 18, showing a 0.15-inch region of fatigue prior to the growth mechanism transitioning to overload. A fractograph of the crack 8 fracture face is shown in figure 19, illustrating the direction of crack growth as well as identifying a few of the more prominent fatigue striations, or crack face features.

FIGURE 17. LOCATIONS OF CRACKS 7 AND 8 ON THE RIGHT WING FRONT CARRY-THROUGH OUTER (-33) CHANNEL FORWARD SIDE

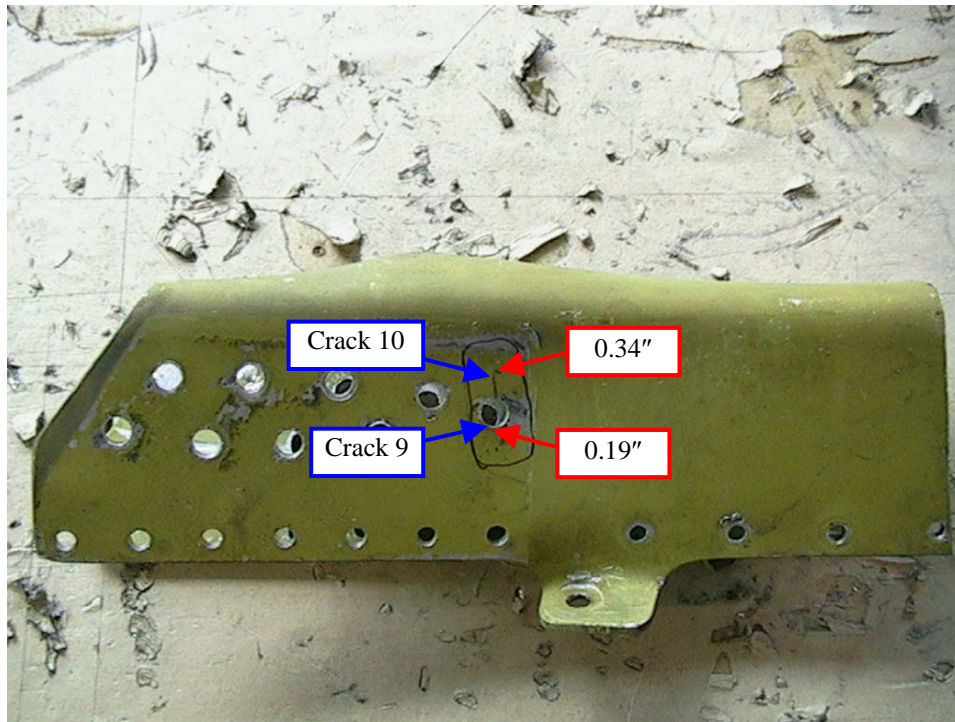
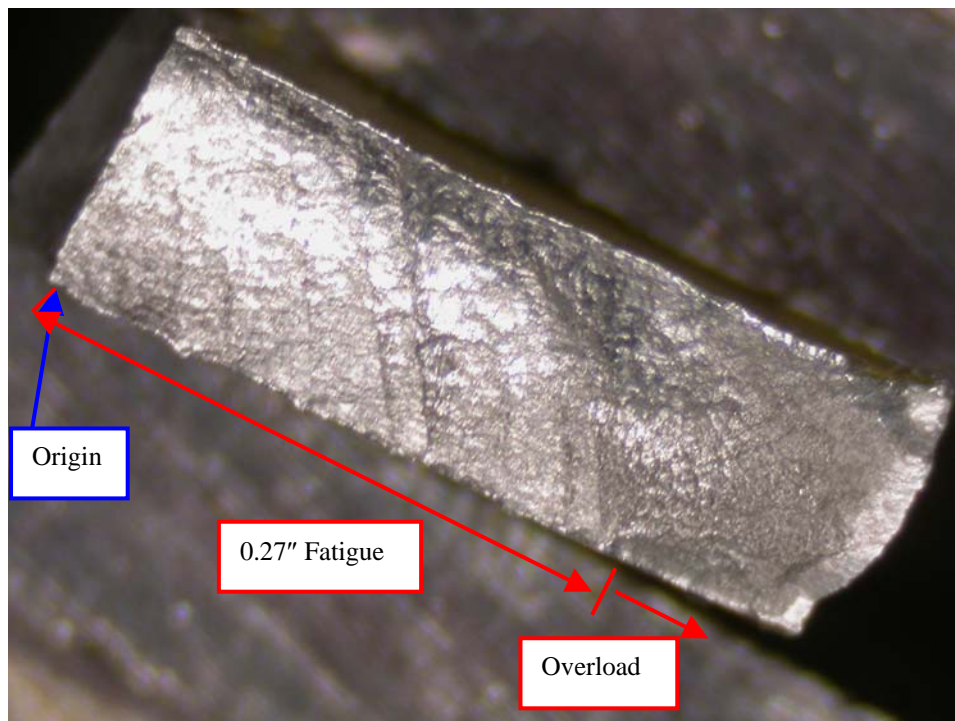
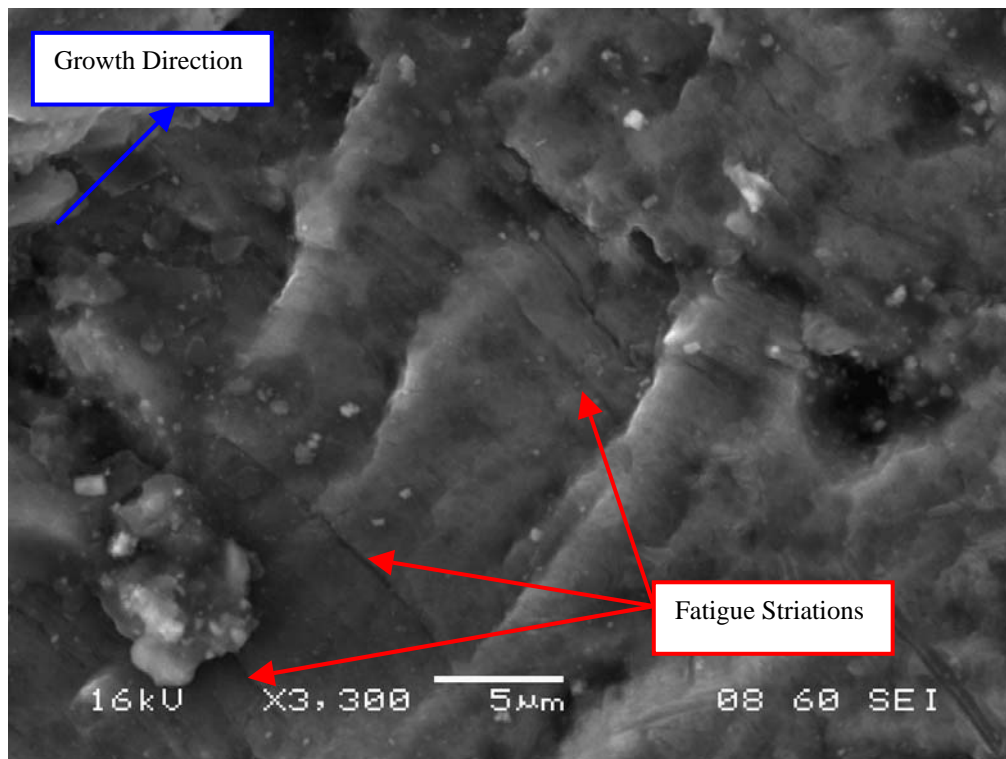
Figure 20 shows the locations of cracks 9 and 10 on the right wing front carry-through outer (-33) channel aft side. Crack 9 measured 0.19 inch and was not opened for examination. Crack 10 had a total length of 0.34 inch and a fatigue length of 0.27 inch, as shown in figure 21. This picture of the crack face also shows the location of the origin and the region of failure due to overload. Crack 10 had not propagated through the entire thickness of the channel. Figure 22 shows a fractograph of crack 10 with the growth direction indicated and prominent fatigue striations identified.

FIGURE 20. LOCATIONS OF CRACKS 9 AND 10 ON THE RIGHT WING FRONT CARRY-THROUGH OUTER (-33) CHANNEL AFT SIDE

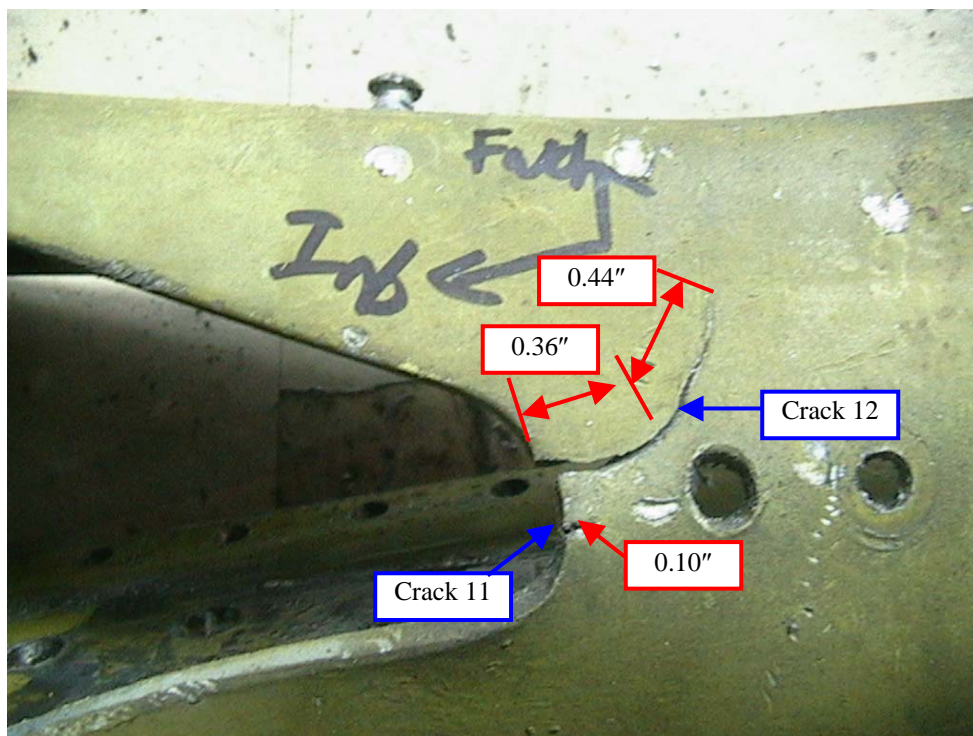
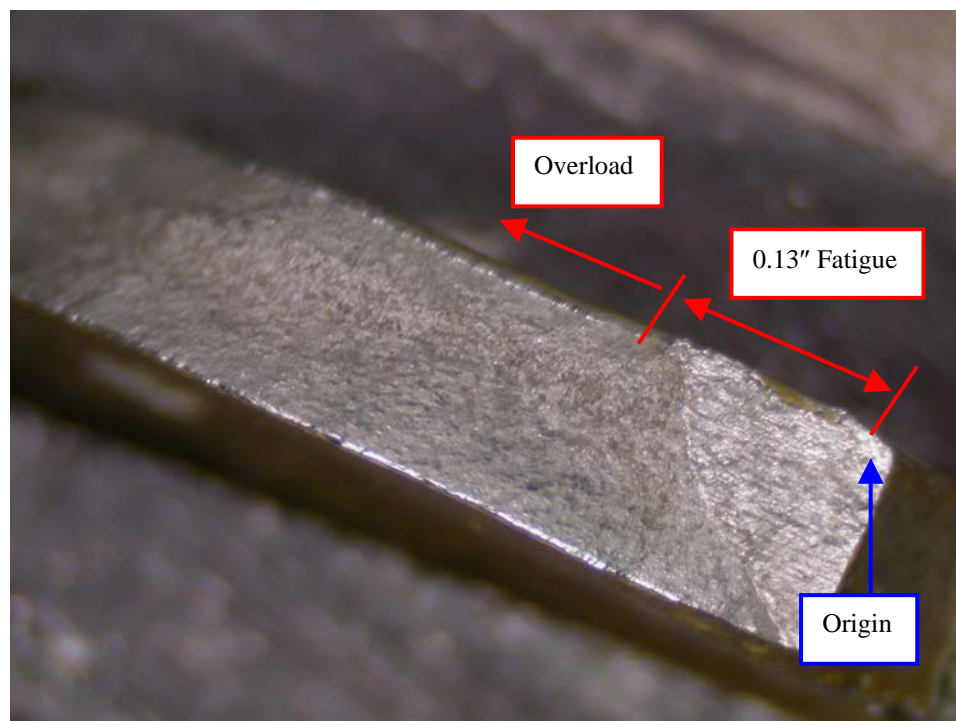
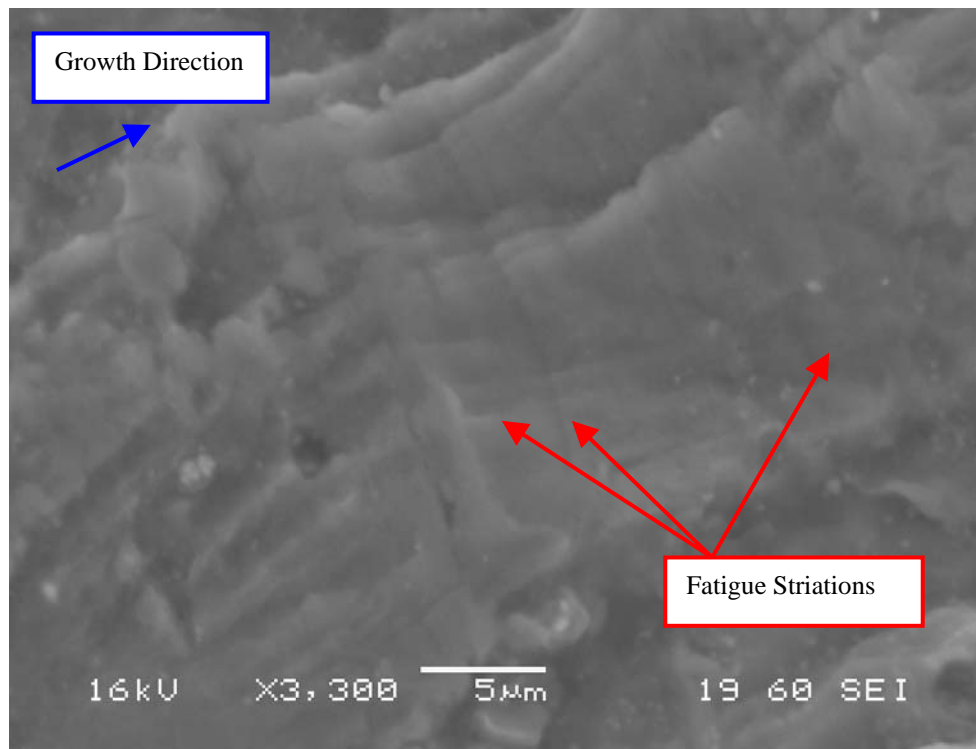
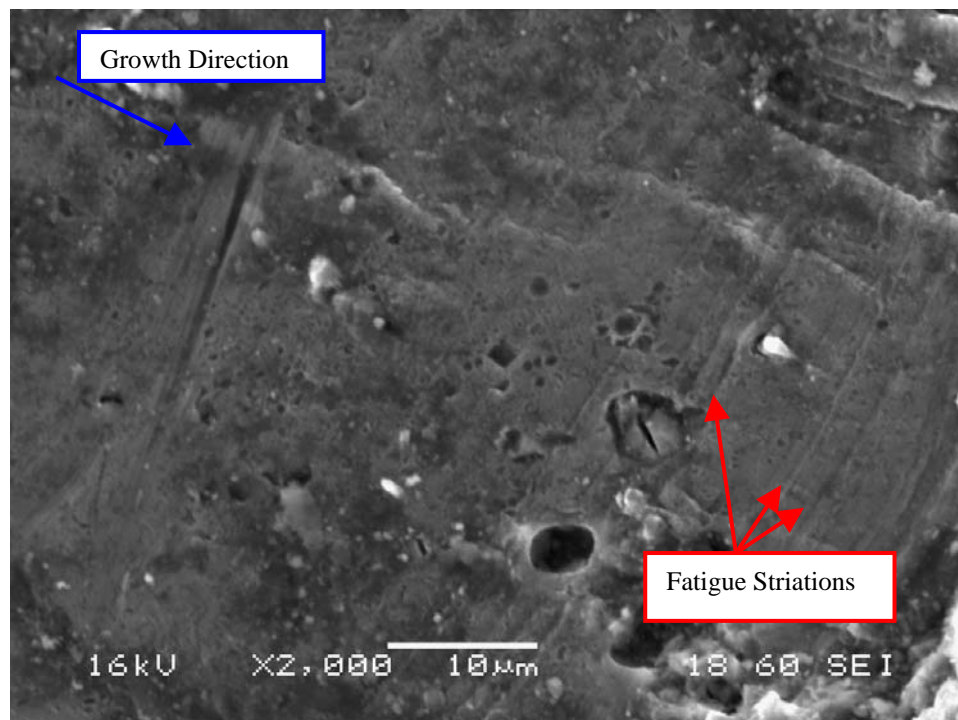
Figure 23 shows the locations of cracks 11 and 12 on the right wing front carry-through outer (-33) channel lower surface. Crack 11, which measured 0.10 inch in length, was not opened for examination. Crack 12 had a total length of 0.80 inch with a fatigue region of 0.13 inch, as shown in figure 24. The remaining growth of the crack was due to overload. Fractographs of crack 12 are provided in figures 25 and 26, showing crack propagation directions as well as identifying fatigue striations.

FIGURE 23. LOCATIONS OF CRACKS 11 AND 12 ON THE RIGHT WING FRONT CARRY-THROUGH OUTER (-33) CHANNEL LOWER SURFACE

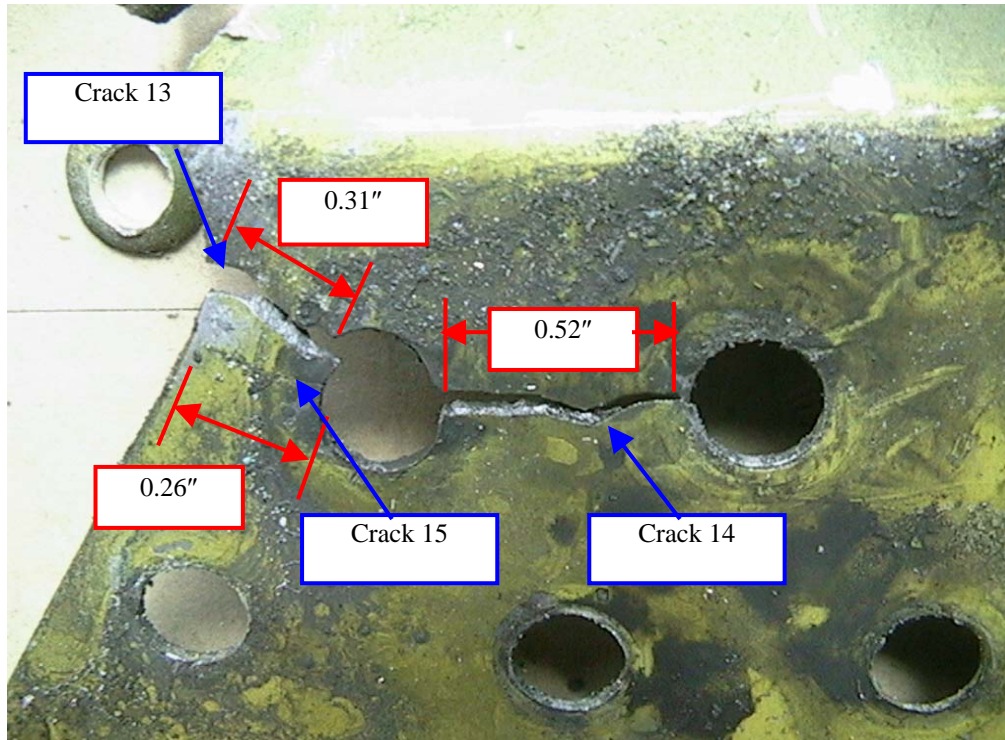
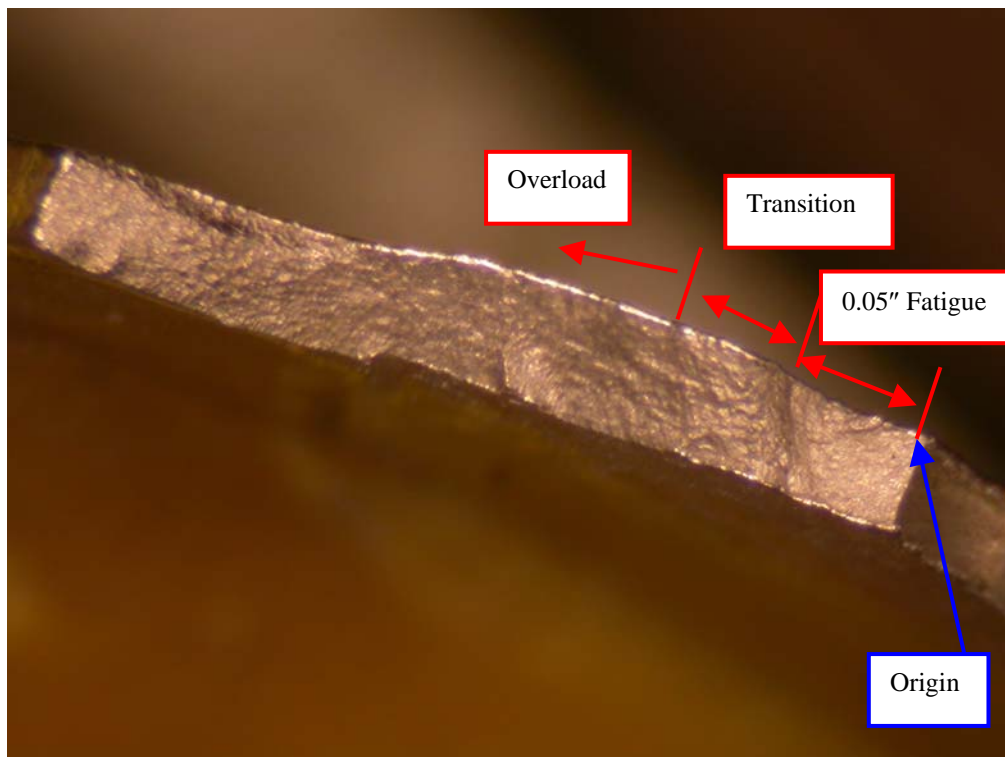
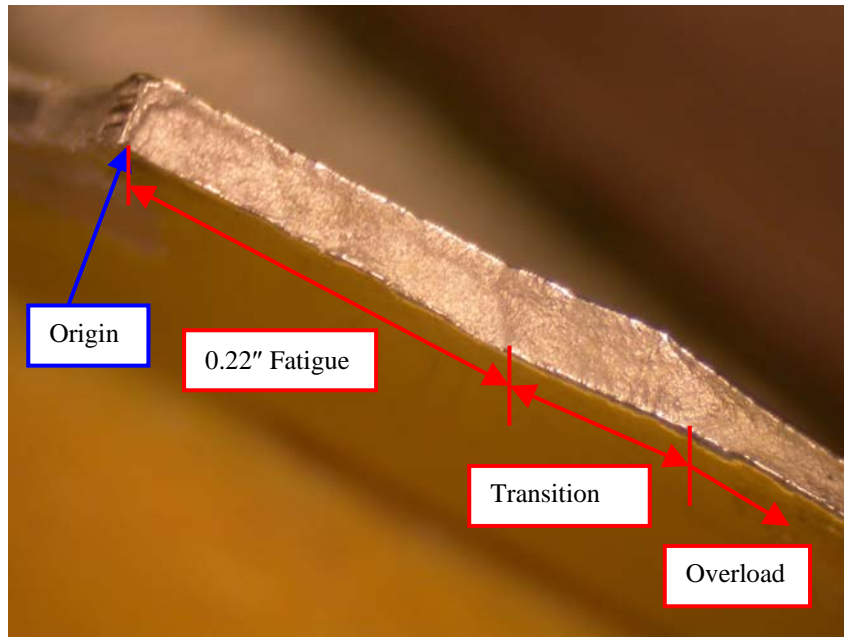
Figure 27 shows the right wing front carry-through aft side structural stackup. The locations of cracks 13-15 are shown in figure 28. Crack 13 had a total length of 0.31 inch with an initial fatigue length of 0.05 inch, which was through the thickness, as shown in figure 29. Figure 29 also shows the location of the origin of this crack. Crack 14 had a total length of 0.52 inch, with an initial fatigue length of 0.22 inch. This crack was also completely through the thickness. The fracture face for crack 14 is provided in figure 30 and shows the location of the origin along with the existence of a transition period of rapid growth, which was comprised of unstable fatigue that extended the crack length 0.05 to 0.10 inch prior to the final growth increment due to overload. Crack 15 had a total length of 0.26 inch and was not opened for examination.

FIGURE 28. LOCATIONS OF CRACKS 13, 14, AND 15 ON THE RIGHT WING FRONT CARRY-THROUGH MIDDLE LAYER AFT SIDE WEB SKIN

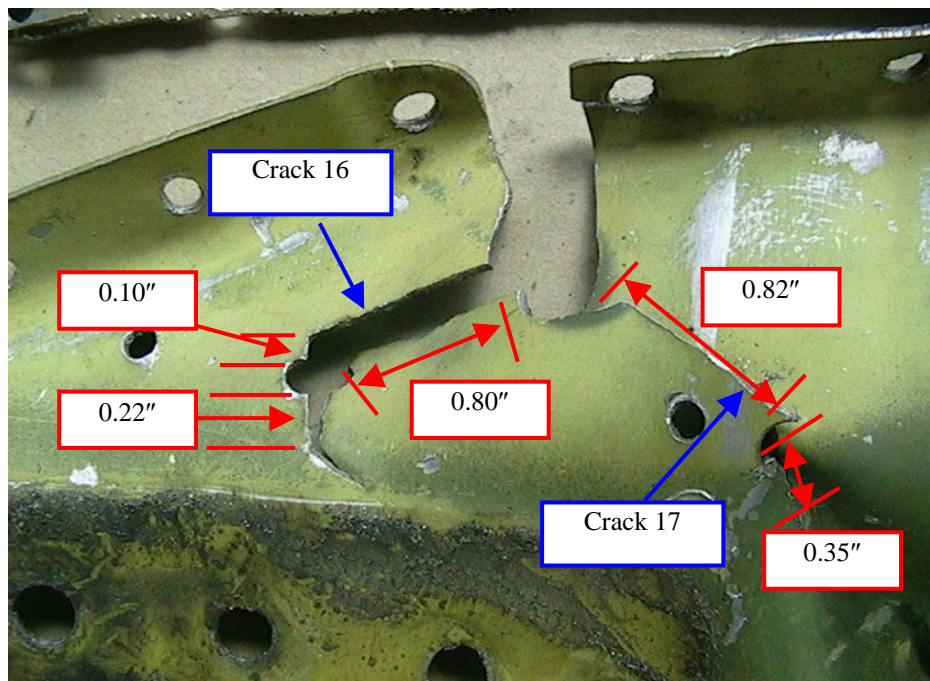
The locations of cracks 16 and 17 are shown in figure 31. The total length of crack 16 was 1.12 inches, while the total length of crack 17 was 1.17 inches. Both of these cracks were opened and examined, but due to extensive metal smearing of the crack faces, no failure mode could be determined.

FIGURE 31. LOCATIONS OF CRACKS 16 AND 17 ON THE RIGHT WING FRONT CARRY-THROUGH MIDDLE LAYER AFT SIDE WEB SKIN
